# CENTRUM PÆLE A/S

Test Site, DK-Hedensted – Exhumation P5, 19 August 2024

Observation Report

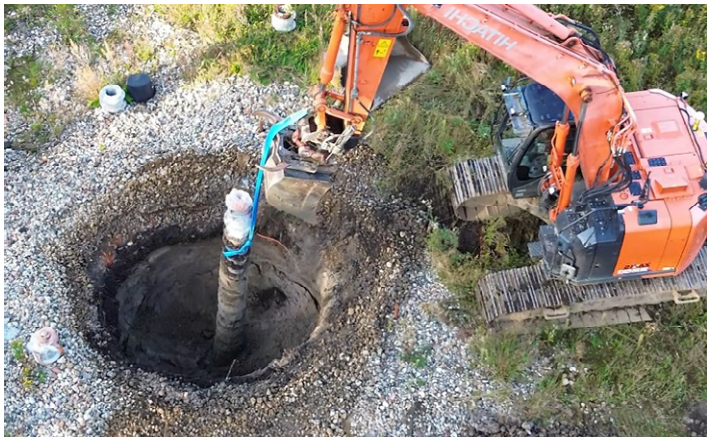
Step	Activity	High-level Observations
1	Excavation around the pile to enable pile extraction from the surrounding soil.	The excavation caved in due to the GWL being above the pile tip elevation. It was not possible to fully excavate the pile prior to lifting it from its position.

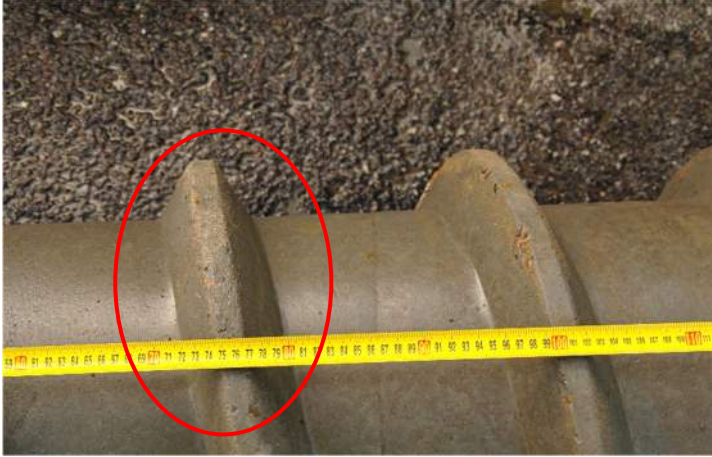
Abbreviation	Category	Description with Sample Pictures
Ab	Abrasion	<p>The smooth concrete surface of the thread appears to have been roughened by the soil contact during installation.</p>

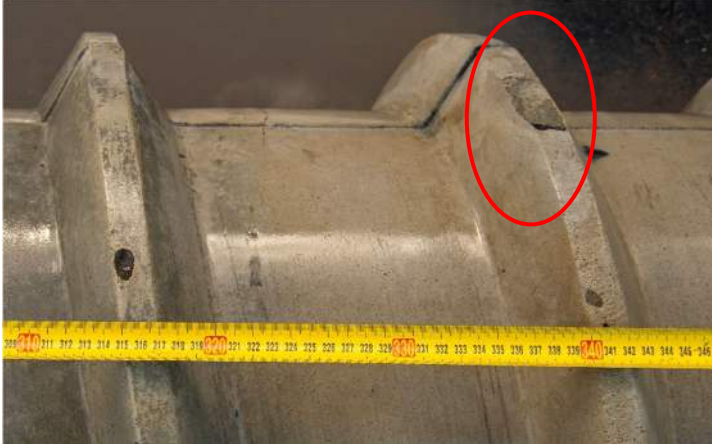
AP	Air Pocket	<p>Idents in the surface of the thread interpreted as air pockets trapped in the mould during casting.</p>

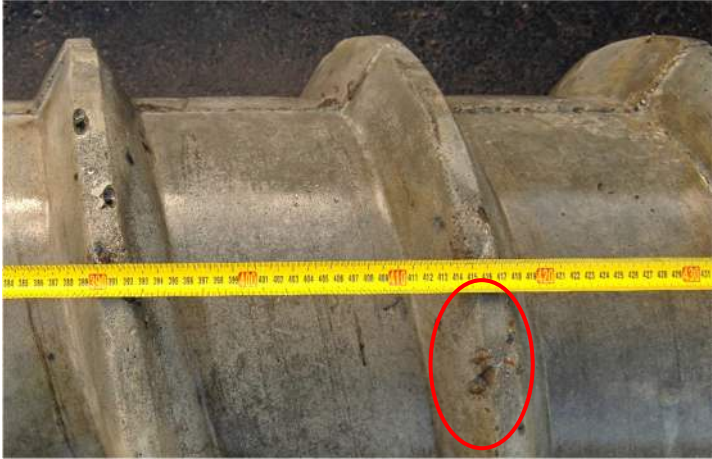
Sc	Scaling	<p>Chips of concrete cover missing at the thread crest and/or flanks.</p>

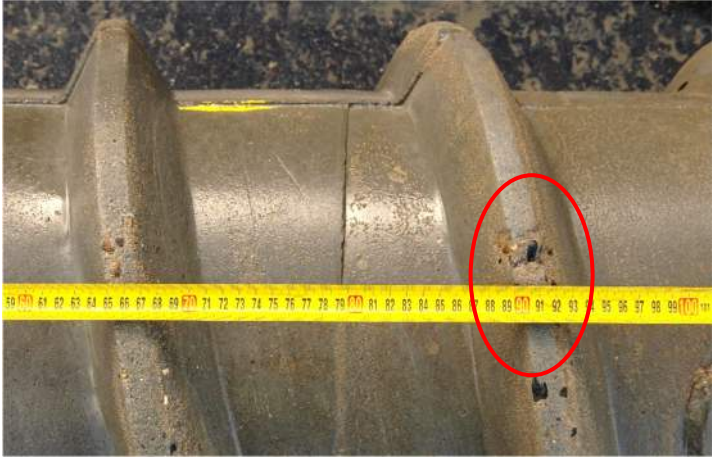
<p>Sc-W</p>	<p>Scaling with wear</p>	<p>Missing chips of concrete cover with traces of wear</p>

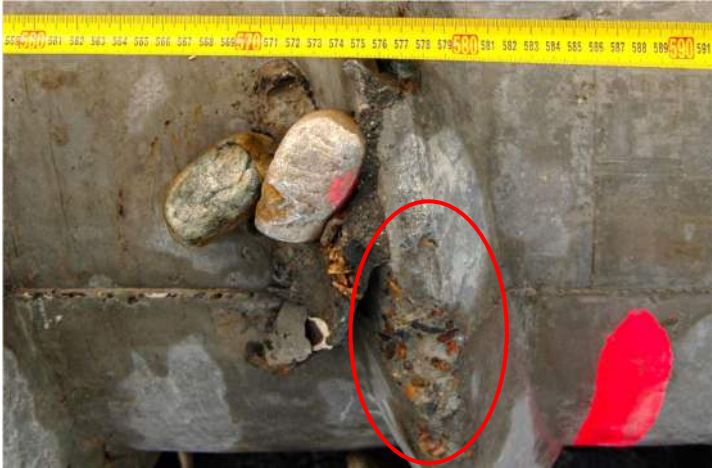
<p>Sc-R</p>	<p>Scaling, recent</p>	<p>Missing chips of concrete cover with a blueish tint interpreted as recent and caused by the excavation and/or mechanical cleaning of the pile.</p>

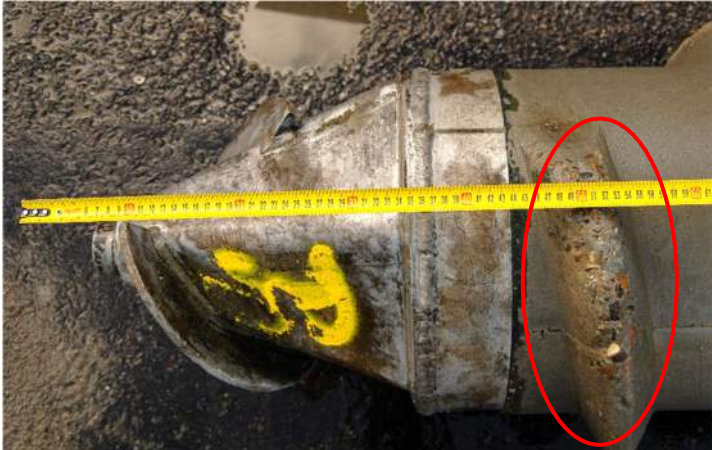
<p>Wr</p>	<p>Wear</p>	<p>The concrete surface and aggregates appear to have been worn by the soil contact during installation.</p>

- Significant wear is found at the leading edge of the thread just above the steel pile tip. Less significant wear is found on thread crest where the mould elements have not been completely aligned i.e. the part of the thread protruding farthest into the surrounding soil exhibits the most wear.
- Air pockets are with one exception found at Face A, which implies it was facing upwards in the mould.
- The scaling with wear is found at the lower part of the pile which implies that the scaling was present prior to or occurred during the early stages of installation.

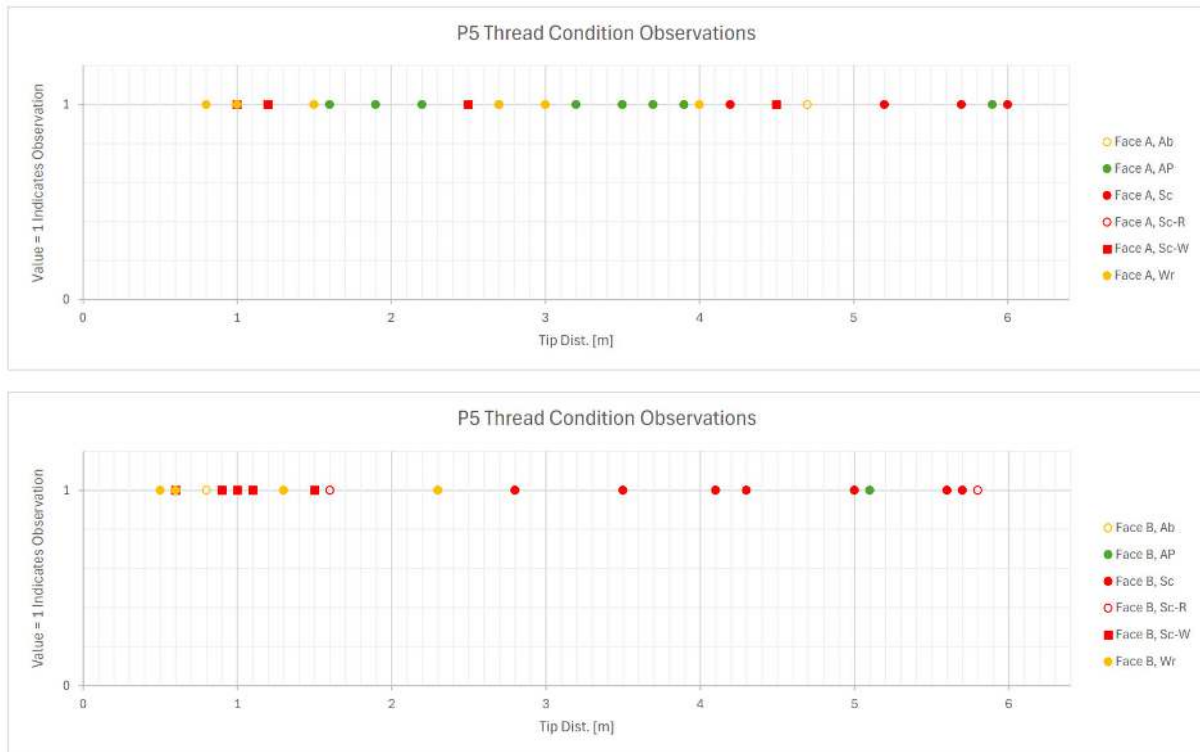
Figure 4-1: Photo Documentation Analysis Summary, Diagram Format

Only the observations for cleaning step 3 are shown in Figure 4-1.

The observed anomalies on the CPSP threads (categories Ab, AP, Sc, Sc-R, Sc-W, and Wr) are mostly scattered along the pile longitudinal axis, however with some exceptions:

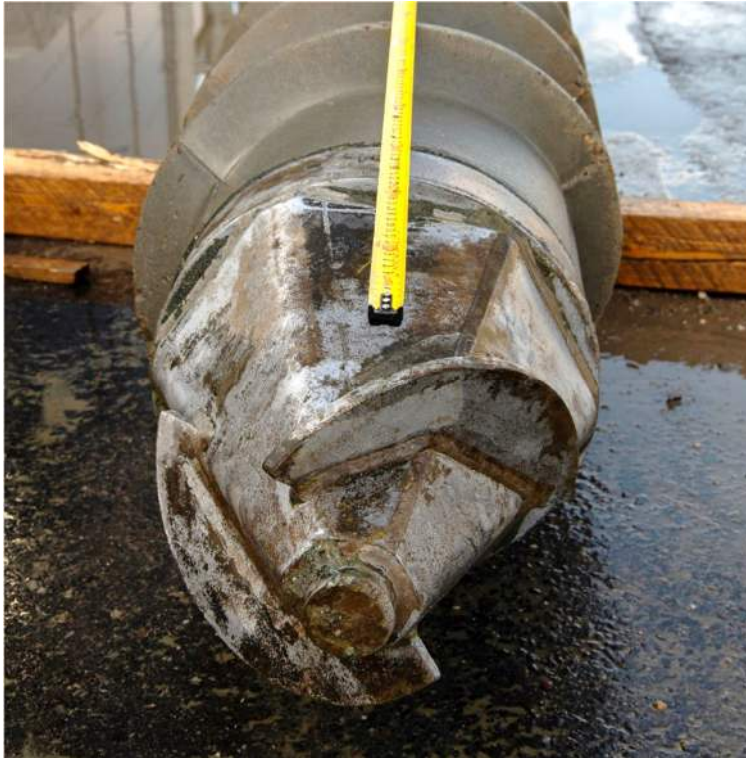
*Figure 4-2: Steel Pile Tip*

The steel pile tip exhibits light wear on the tip and the helix plates, refer Figure 4-2.
