# CENTRUM PÆLE A/S

Test Site, DK-Hedensted – Exhumation P5, 19 August 2024

Observation Report

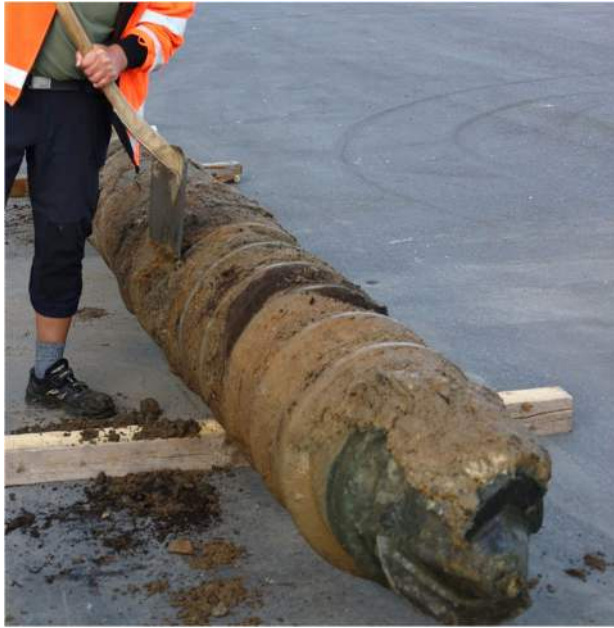
<p>The cleaning was done in steps:</p> <ol style="list-style-type: none"><li>1. Mechanical cleaning of the thread crests for a first impression of the thread condition.</li></ol>

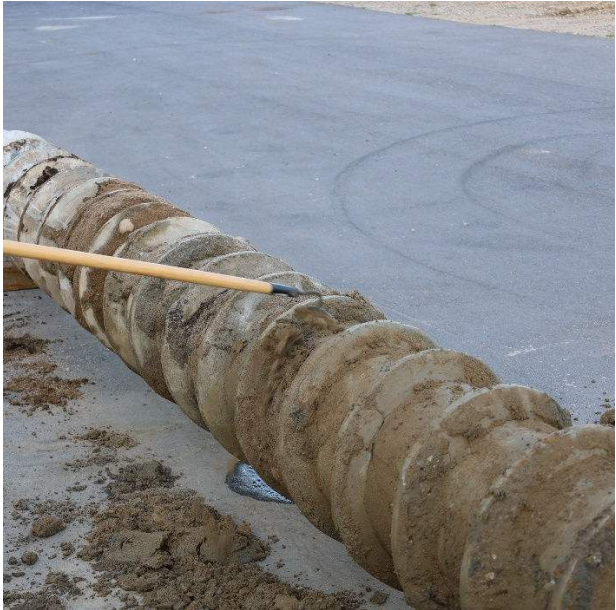
<p>2. Mechanical cleaning between the thread flanks and pile shaft for investigating the thread condition further.</p>

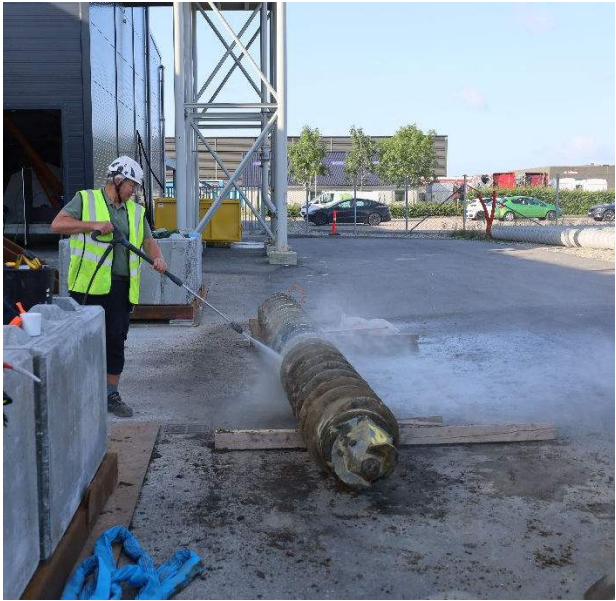
<p>3. Jet cleaning of the pile surface for a final investigation of the thread condition.</p>

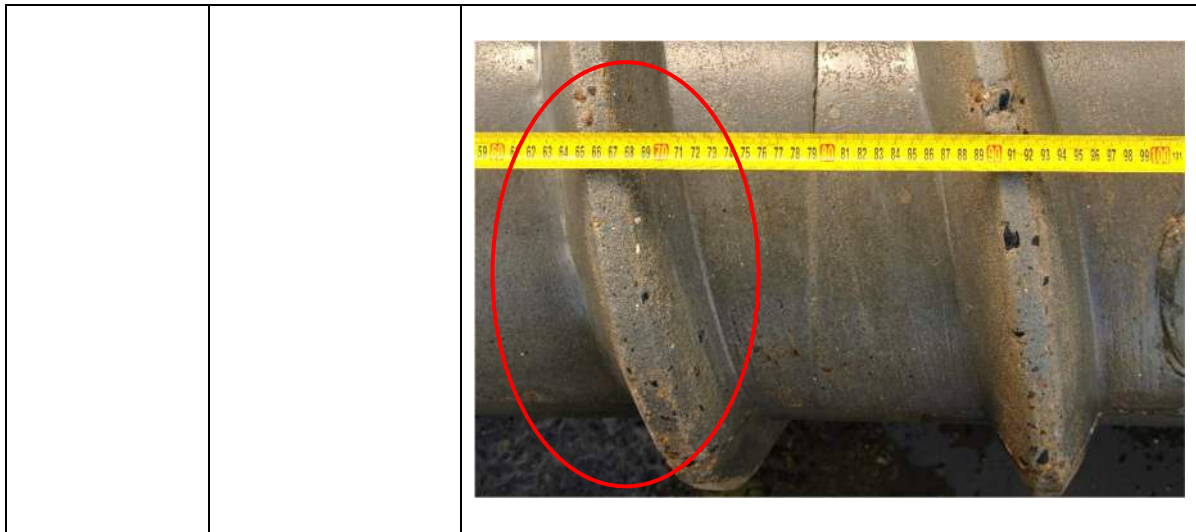
Figure 4-1: Photo Documentation Analysis Summary, Diagram Format

Only the observations for cleaning step 3 are shown in Figure 4-1.

The observed anomalies on the CPSP threads (categories Ab, AP, Sc, Sc-R, Sc-W, and Wr) are mostly scattered along the pile longitudinal axis, however with some exceptions:

- Significant wear is found at the leading edge of the thread just above the steel pile tip. Less significant wear is found on thread crest where the mould elements have not been completely aligned i.e. the part of the thread protruding farthest into the surrounding soil exhibits the most wear.
- Air pockets are with one exception found at Face A, which implies it was facing upwards in the mould.
- The scaling with wear is found at the lower part of the pile which implies that the scaling was present prior to or occurred during the early stages of installation.
